Improving Strength of Postbuckled Panels Through Stitching

Dawn C. Jegley

NASA Langley Research Center Hampton, VA 23681

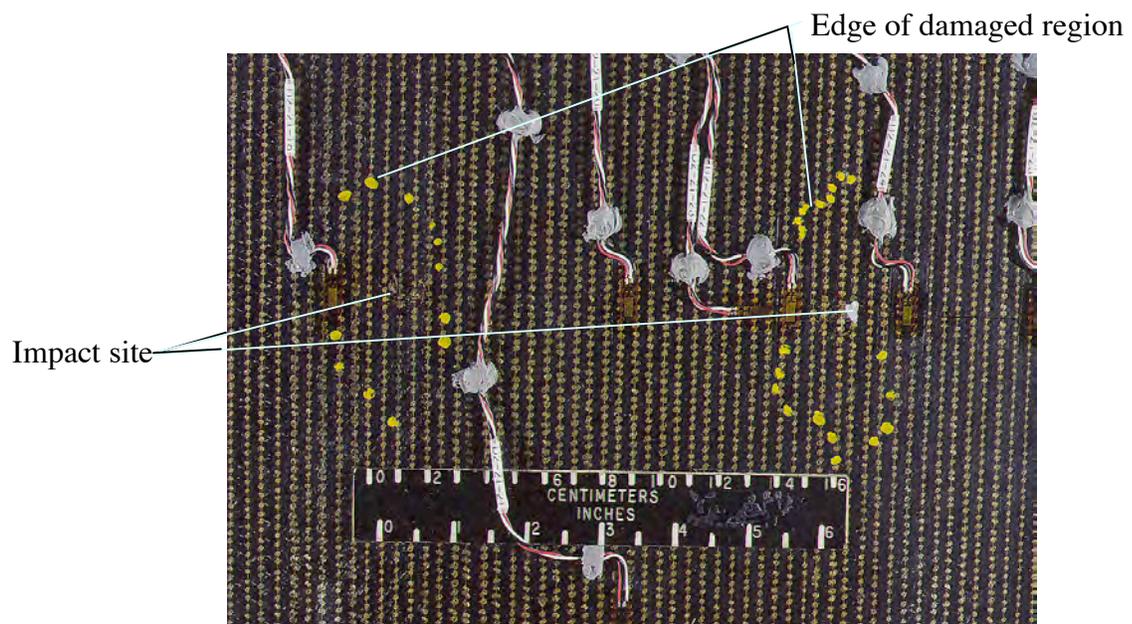
Figure 4. Impact-damage sites.

Two of the three specimens of each design configuration were impacted using a drop-weight impactor with a 25.4-mm-diameter tup prior to compressive loading. The impact energy level was selected based on criteria developed during the NASA-Boeing Advanced Composites Technology (ACT) Program [1,15] to represent “barely visible damage” to a wing skin. The design philosophy used was that impact energies greater than this level would be detected and repaired but damage that was “barely visible” might not be detected and therefore the wing would be required to carry DUL in the presence of this damage. Testing conducted during the early stages of the ACT program determined this energy level to be 135.5 J (100 ft-lb) [16]. This level of damage is also cited as one critical damage criteria in reference 17, which is a design guide for composite aircraft structures. For this reason, an impact energy of 135.5 J was imparted with each impact. However, even though 135.5 J was defined to be “barely visible,” damage resulting from such an impact can be quite visible when the skin is relatively thin. Panel skins were impacted on the unstiffened side opposite the base of a central stiffener. The location of the impact damage sites is shown in figures 1 and 2. Dent depths were measured with a depth gage and ultrasonic examination was used to determine the extent of the damage region. Measured dent depths are given in table 2. Four panels were impacted at two stiffener base locations. A photograph of the damage site of one panel is shown in figure 4. The dots around

the impact site in the photograph indicate the borders of the damage area. One panel with flange-to-skin stitching of each configuration was not damaged prior to loading. One panel with flange-to-skin stitching of each configuration was subjected to the drop weight impact damage prior to loading. The panel without flange-to-skin stitching of each configuration was also subjected to the drop weight impact damage prior to loading. All panels were loaded to failure at room temperature.

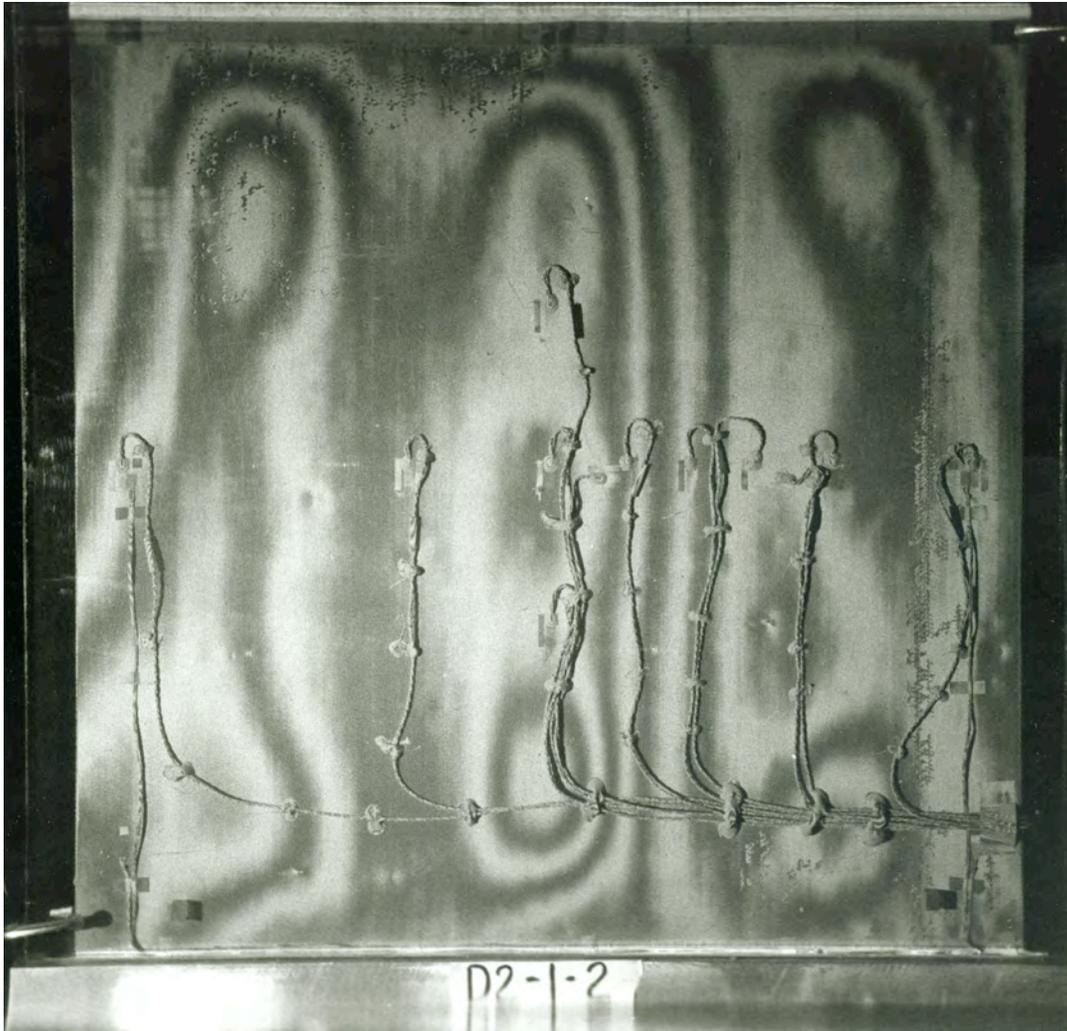
Figure 6a. Experimentally determined out-of-plane deformation pattern of panel 1sc with a load of 734 kN.

A photograph of panel 1sc subjected to a load of 734 kN (165,000 lb) is shown in figure 6a. The buckle pattern is easily determined by the use of moiré interferometry to highlight out-

of-plane displacements. Buckles shown in figure 6a form in all skin bays at this load level. The analytical prediction of the out of-plane deformations of this panel at a load of 757 kN (170,000 lb) is shown in figure 6b and is consistent with the experimental results. Experimental and analytical results of out-of-plane deformations for this panel at a load of approximately 2,225 kN (500,000 lb) are shown in figures 6c and 6d, respectively. These results show fully-formed buckle patterns in all skin bays. Five half-waves can be seen in the moiré patterns in the two outer skin bays and six half-waves in the central bay. Five half-waves are predicted in each bay. The panel failed at a load of 2,510 kN (564,000 lb) and a photograph of this failed panel is shown in figure 7. Deformation patterns for the other control panels, 2sc, 3sc, and 4sc, are shown in figures 8, 9, and 10, respectively. The panel with the thickest skin and the thickest blade (4sc) began to buckle in the central bay prior to failure, but buckles in the outer bays did not fully form prior to failure.

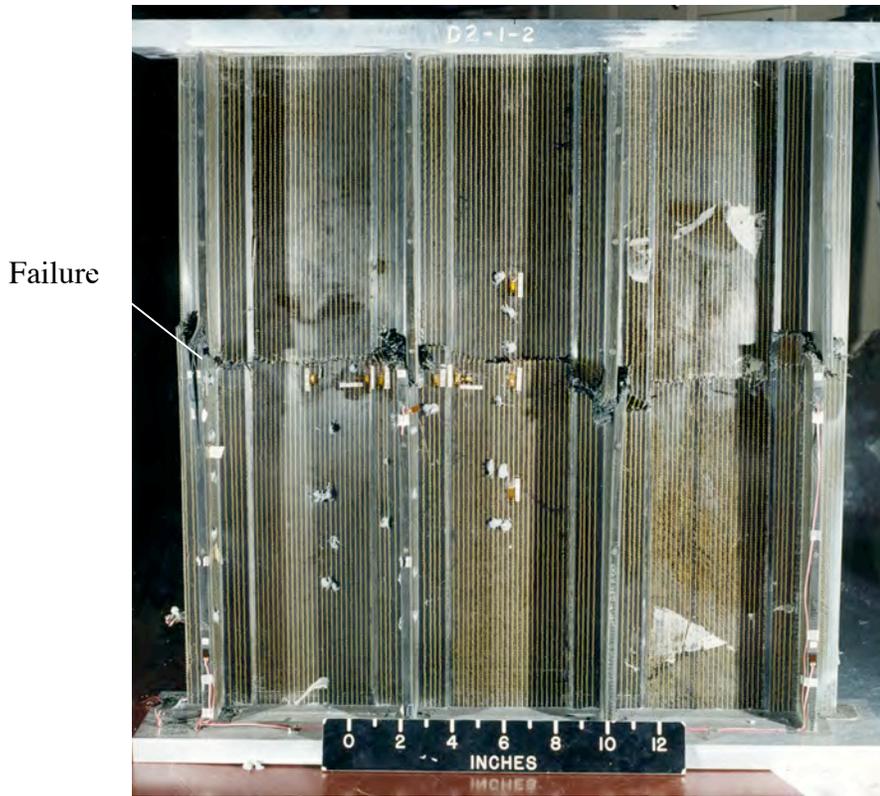
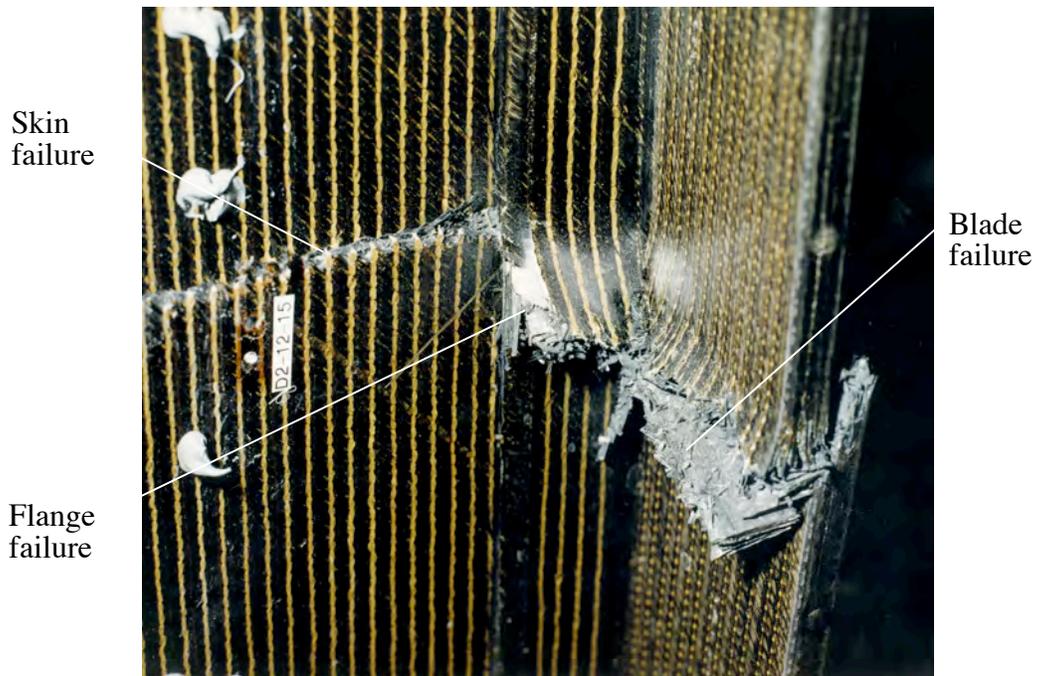
Figure 7. Failure of panel 1sc.

Panels 1sc, 3sc and 4sc failed at the midlength location and also exhibited local skin-flange separation, including broken stitches. Panel 2sc did not fail midlength, but rather approximately at a quarter of the length from the bottom, but also with local skin-flange separation. All control panels failed across the full width of the panel.

Using the technique described in reference 21 and the local model of panel 1sc, the shear and normal forces between the flange and skin were calculated and found to not reach the combined allowables described in the reference. Therefore, the forces between the flange and skin alone are not large enough to cause the skin and flange to separate in the stitched panels. In panel 1sc the flange stays relatively flat while the unsupported skin between the flanges buckles. The in-plane forces trigger the failure, but the stitches contain the damage and prevent propagation. Audible failures were recorded at loads significantly less than the failure loads for

a) Failure across panel width.

b) Failed blade and flange.

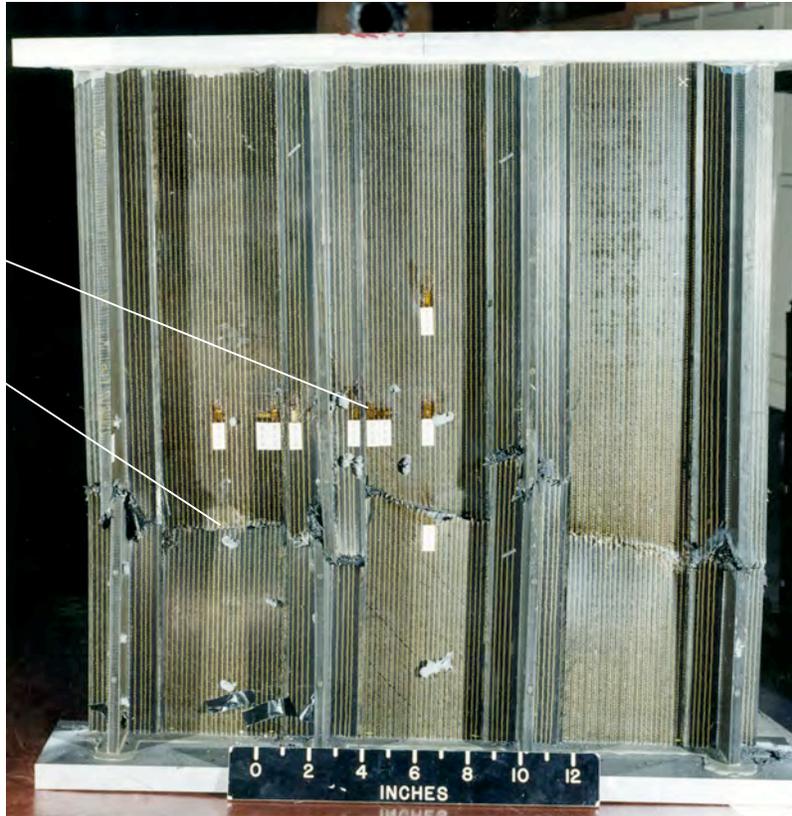
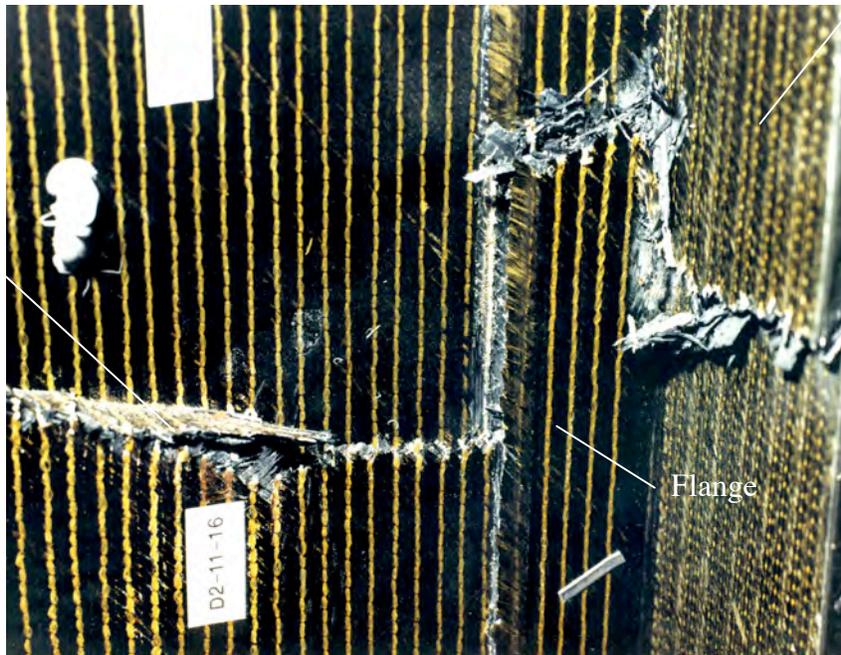
b) Failed blade and flange.
Figure 12. Failure of panel 1si.

Two panels of each configuration were subjected to impact damage prior to compressive loading. All impact-damaged panels failed at loads less than their comparable control panels, as shown in figure 11 where the cross-hatched bars represent failure loads of the impact-damaged panels. Buckling loads were not as severely effected by impact damage compared to the failure loads. As illustrated in the figure, the failure loads of the control panels are 10-20 percent greater than failure loads of the panels with skin-to-flange stitching and impact damage. The failure loads of the control panels are 20-40 percent greater than the failure loads of the impact-damaged panels without skin-to-flange stitching. Photographs of comparable stitched and unstitched impact-damaged panels with configuration 1 are provided in figures 12 and 13, respectively, to demonstrate the difference in failure modes. There is little difference in the appearance of the failed stitched control panel shown in figure 7 and the failed stitched impacted panel shown in figure 12. Neither stitched panel demonstrates significant skin-stiffener separation. However, without stitching, the flange can separate from the skin over lengths greater than 140 mm, as shown in figure 13. Stitching suppresses this delamination and limits the damage region. While stitching does not bring the impact-damaged panels failure loads up

the level of the control panels, it can improve the load carrying capability of damaged panels. Similar damage is seen in the failed panels of other configurations.

Back surface of impact site

Failure

a) Failure across width.

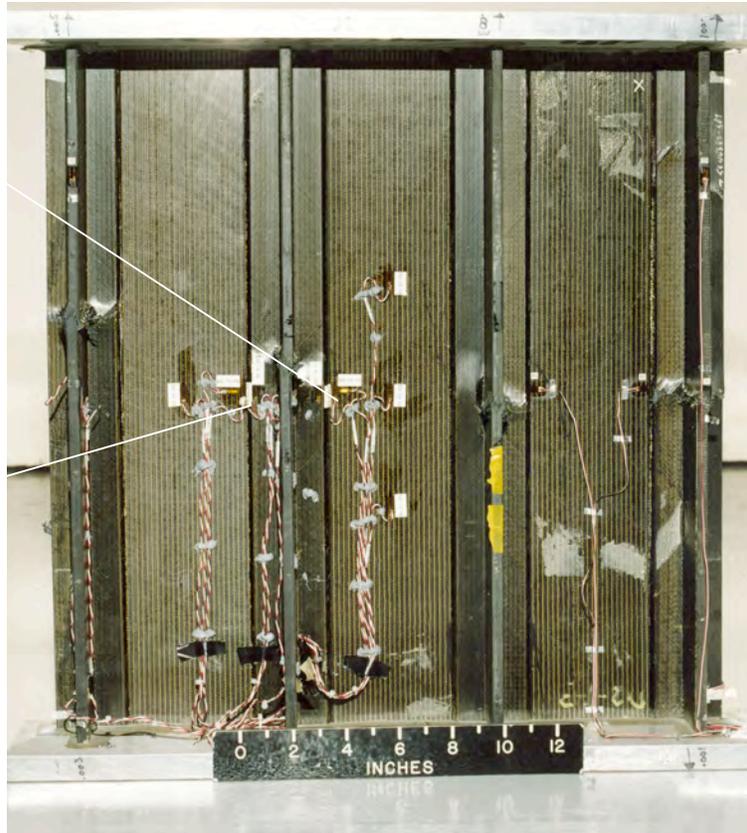
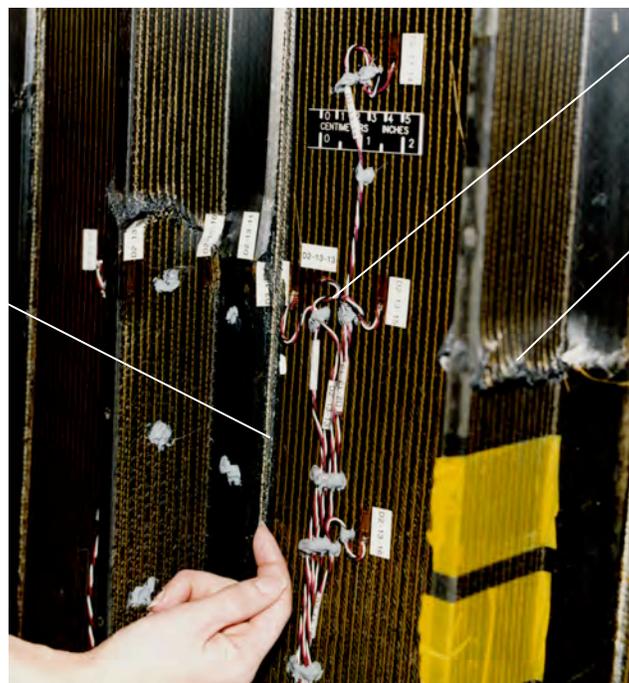
b) Failed blade and flange.
Figure 13. Failure of panel 1wi.

a) Failure across width.

Delamination

Back surface of impact site

Broken blade
